## MEMORANDUM

**Project:** Gold King Interim Water Treatment Plant (IWTP)  
**Location:** Gladstone, Colorado  
**Prepared for:** Emergency Response Unit – US EPA Region 8

**Reporting Period:** May 9 – May 16  
**Report No.:** 21

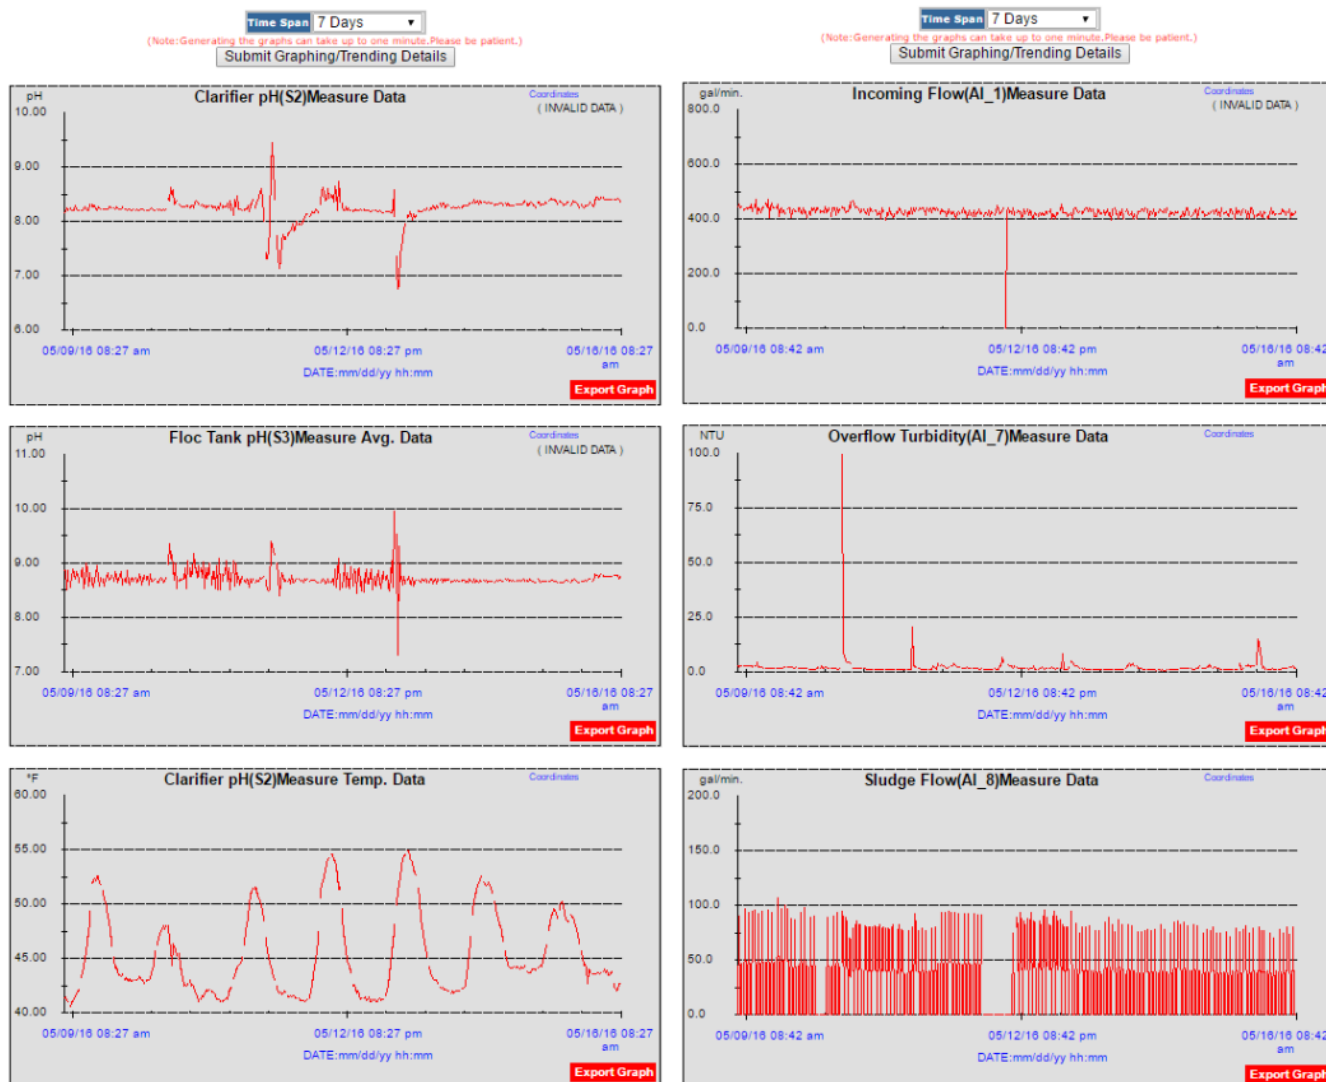
- The following graphs provide trending information during the previous 7 days. The dataloggers collect control information from the Lime Circuit (left) and Flow Circuit (right) Programmable Logic Controllers (PLCs) at the Gold King IWTP. Over the reporting period (5/9/16 – 5/16/16 inclusive) Alexco treated 4.57 million gallons at an average flow rate of 454 gpm with all discharged treated water leaving the 12" HDPE pipeline.

- Please note: Several days each week, the Alexco operators check the pH at both the flocc tank and clarifier discharge. During this time, the probe is placed in vinegar (acid), and three pH buffers – 4, 7, and 10. While the probe is in the acid/buffer, the datalogger may capture one of those points for tracking purposes, which explains the occasional pH spikes seen on the graph.
- On 5/11 and 5/13, the IWTP experienced high TSS spikes from the upper ponds, which caused some fluctuation of the pH at the clarifier as the peristaltic pumps both over and under shot lime addition.
- On 5/12, the Alexco operator briefly closed the incoming butterfly valves.
- Instantaneous spikes of the Overflow Turbidity Meter are associated with routine cleaning. However, a longer TSS spike on 5/15 is due again to a high TSS spike from the upper pond, potentially caused by storm conditions.

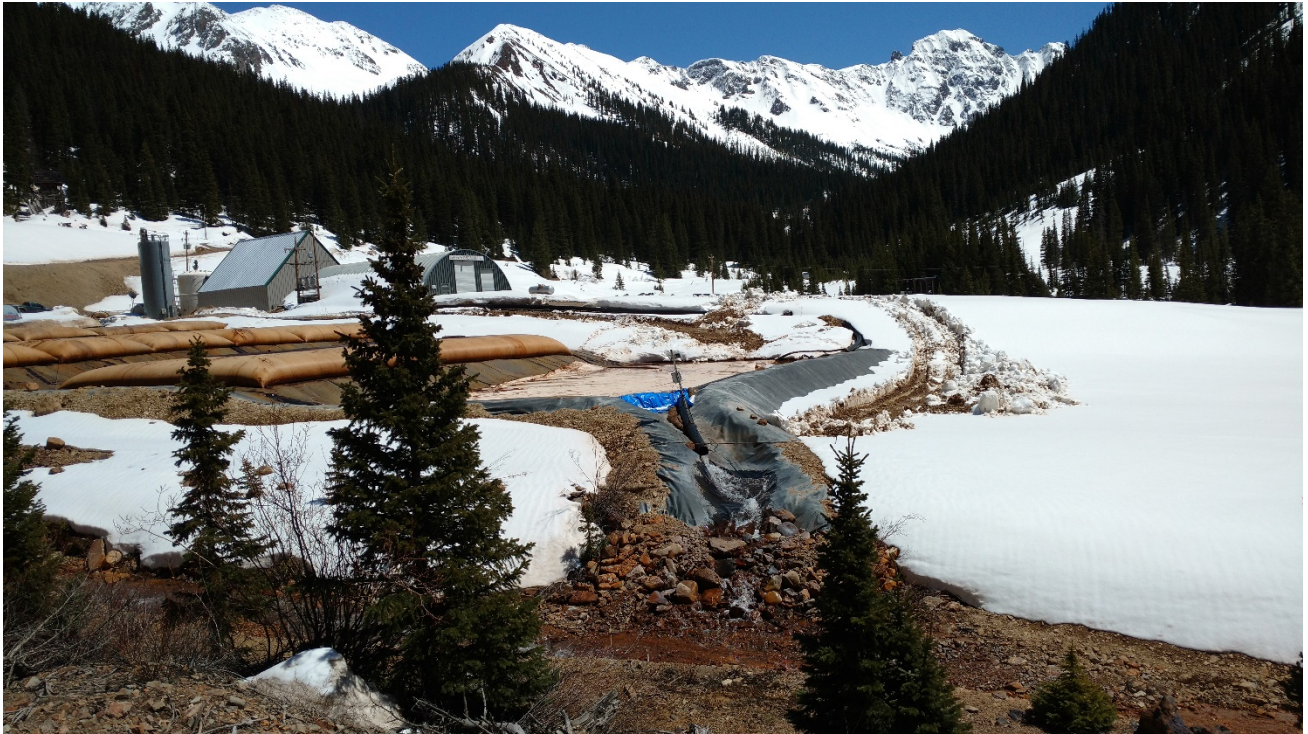
Photo 1: Site from the road near the IWTP discharge pipe – Taken on 5/12/2016

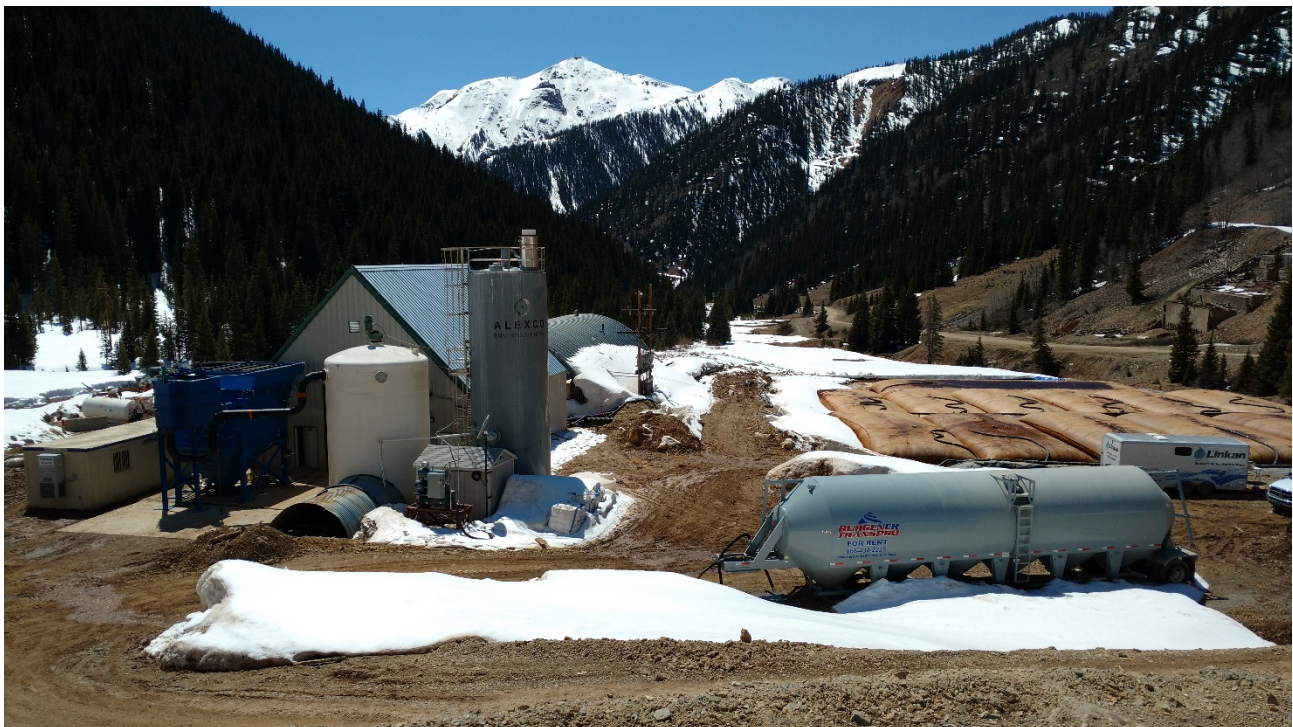
Photo 2: View of IWTP from the Upper Road – Taken on 4/12/2016

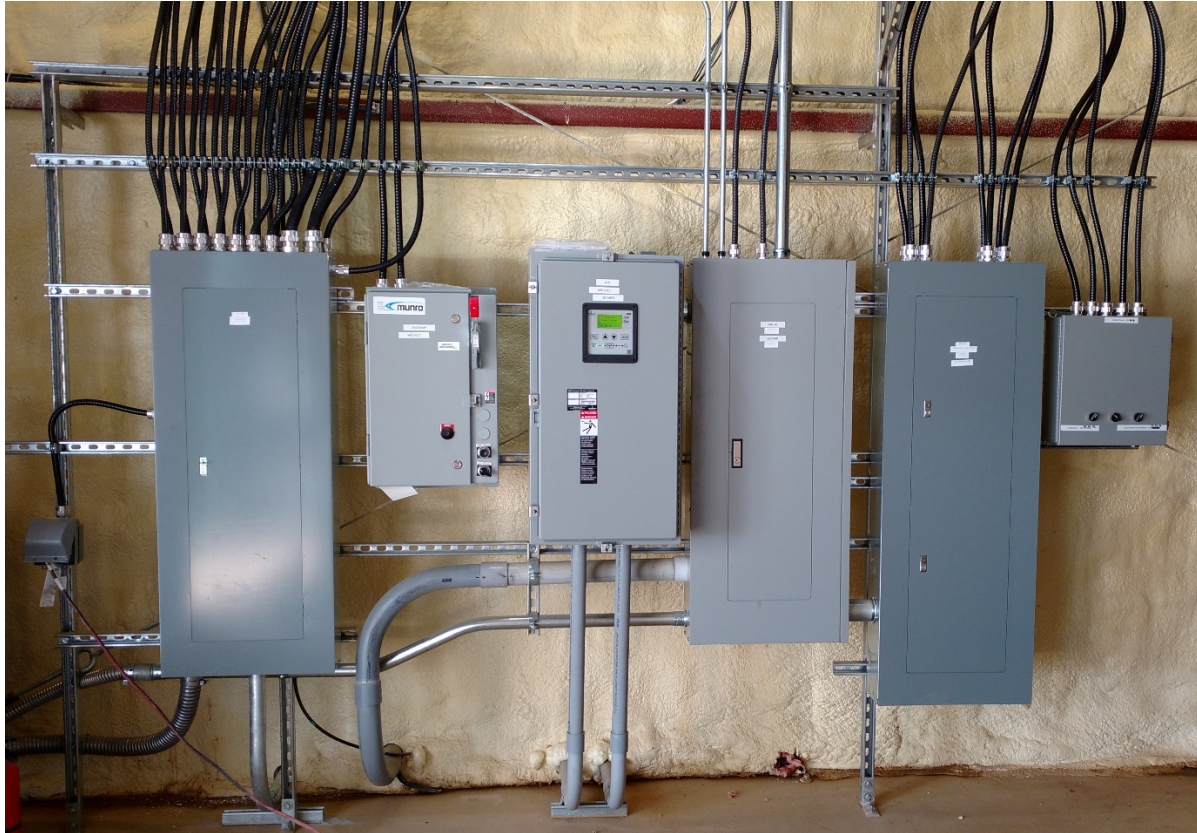
- **Electrical Upgrades** – Alexco's selected electrical contractor (Rapid Energy) began electrical upgrades on Friday, April 15<sup>th</sup>. These upgrades passed final inspection from the State Inspector on Wednesday, May 11<sup>th</sup> (see Photo 4).

Photo 3: Final installation of electrical panels – Taken on 4/12/2016

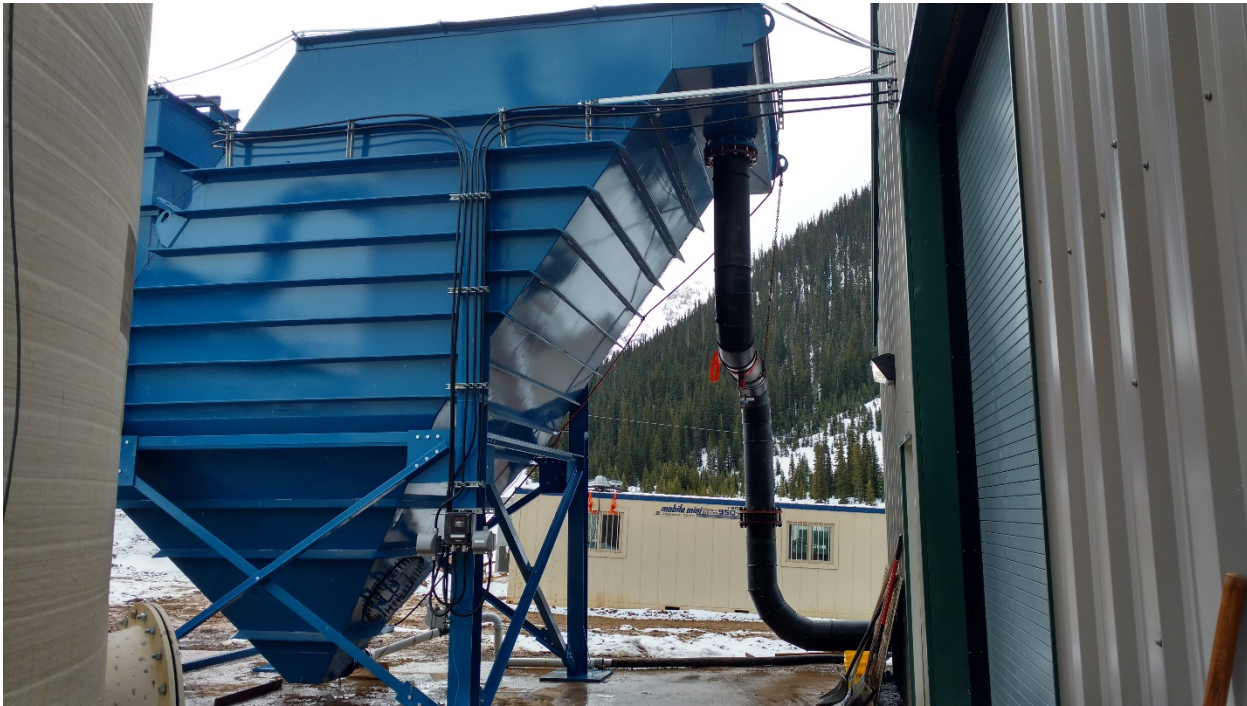
- **Second Clarifier** – Alexco has installed and operated a 2<sup>nd</sup> clarifier (rental) and supporting infrastructure that may be required for spring melt. The system was tested and became operational on Sunday, May 8<sup>th</sup>.

Photo 5: 2<sup>nd</sup> Clarifier, discharge line near IWTP – Taken on 4/10/2016

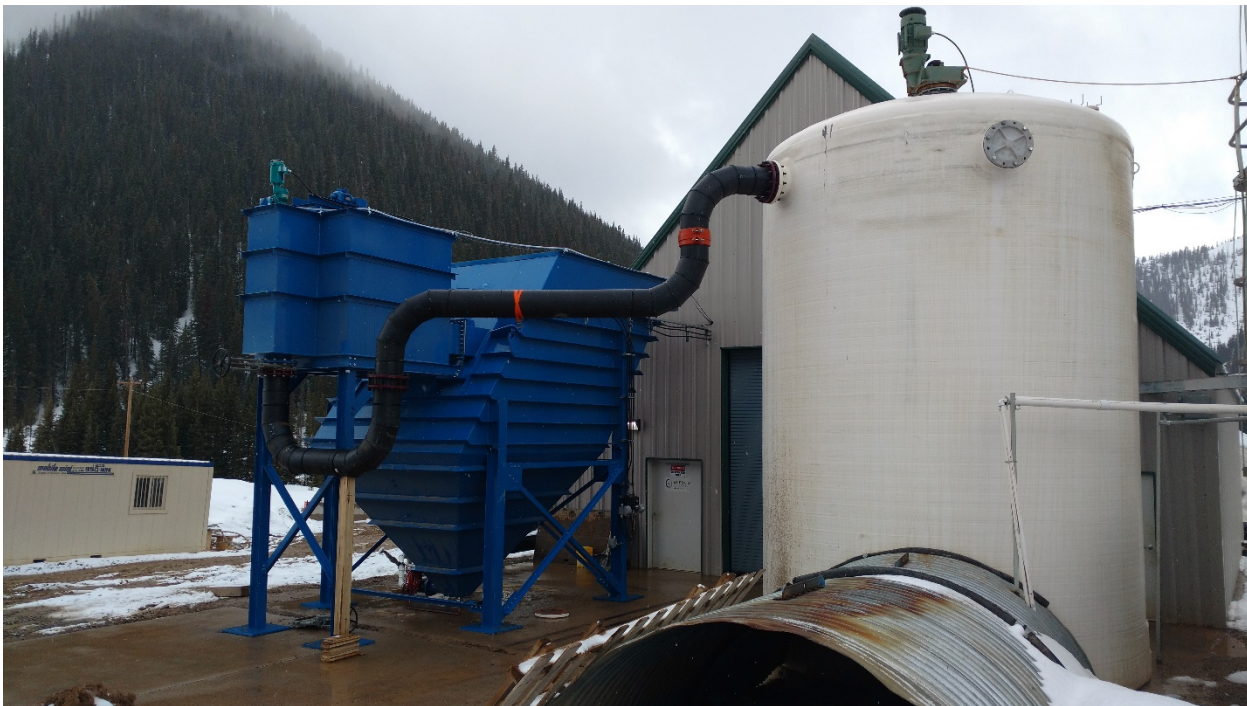
Photo 6: Incoming line from the Reactor Tank – Taken on 4/10/2016
